Enhancement of the Fatigue Performance of Ti-6Al-4V Implant Products

**Dematapaksha Hewage
Ruminda Jeewantha Wimalasiri**

**A thesis submitted in partial fulfilment of the requirements of
Sheffield Hallam University
for the degree of Doctor of Philosophy**

January, 2009

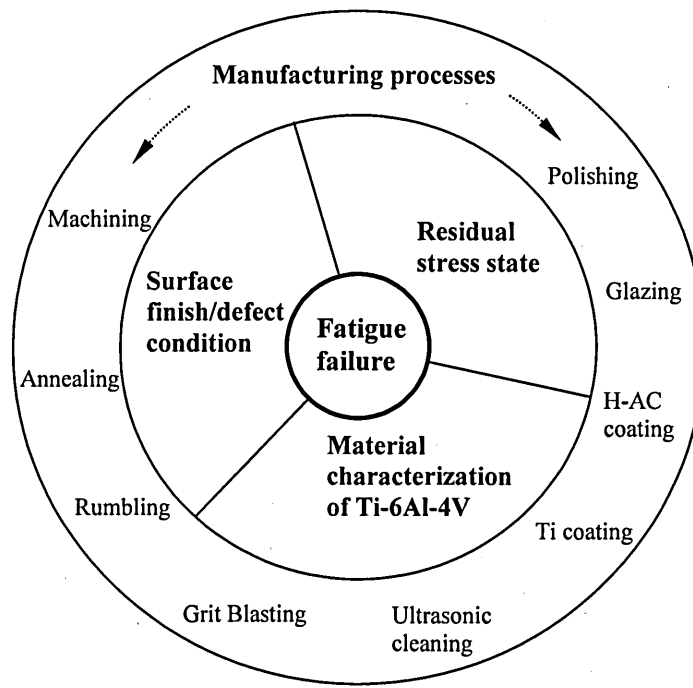
Fig.1: Main components considered in investigation of fatigue behaviour of hip implants made out of Ti-6Al-4V alloy.

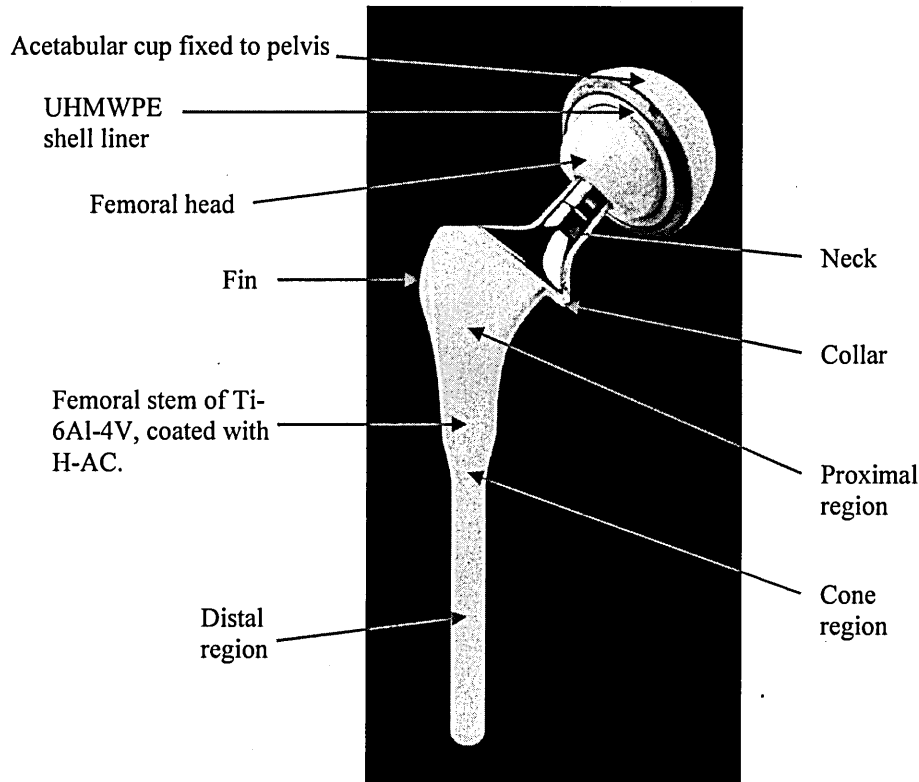
Fig.2: JRI Furlong[®] H-A.C. Supravit[®] coated hip replacements made out of Ti-6Al-4V.

A Furlong[®] H-AC (Hydroxyapatite Ceramic) total hip replacement made by JRI Ltd is shown in Fig.2. The stem has a triangular region (proximal region) just below the neck with a small fin to prevent rotation. Below there is a cone shaped region to create mechanical stability followed by a cylindrical distal region. In coated implants proximal, cone and distal regions are totally coated with H-AC. The collar to tip of the neck region is machined and polished. The distal cylindrical section comes in different sizes to accommodate different patient groups. Also larger diameters and longer length stems are needed in revision implant replacement surgeries.

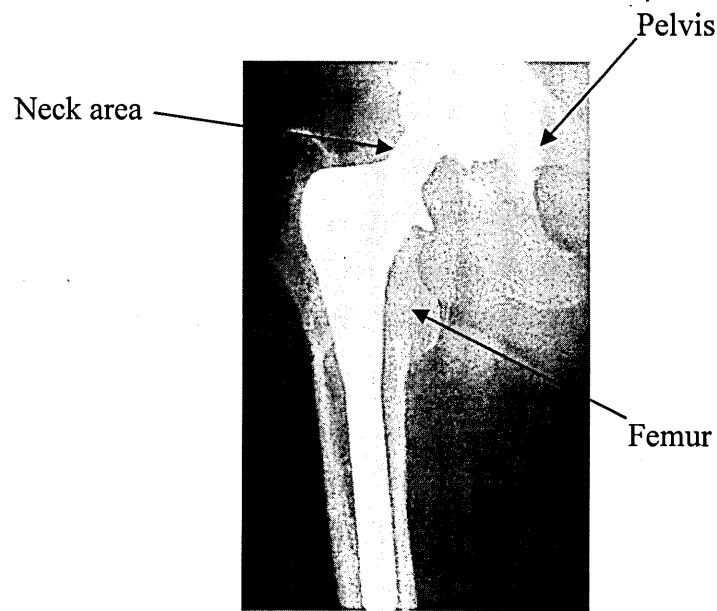
Fig.3: Hip implant fixation, under in-vivo conditions [1].

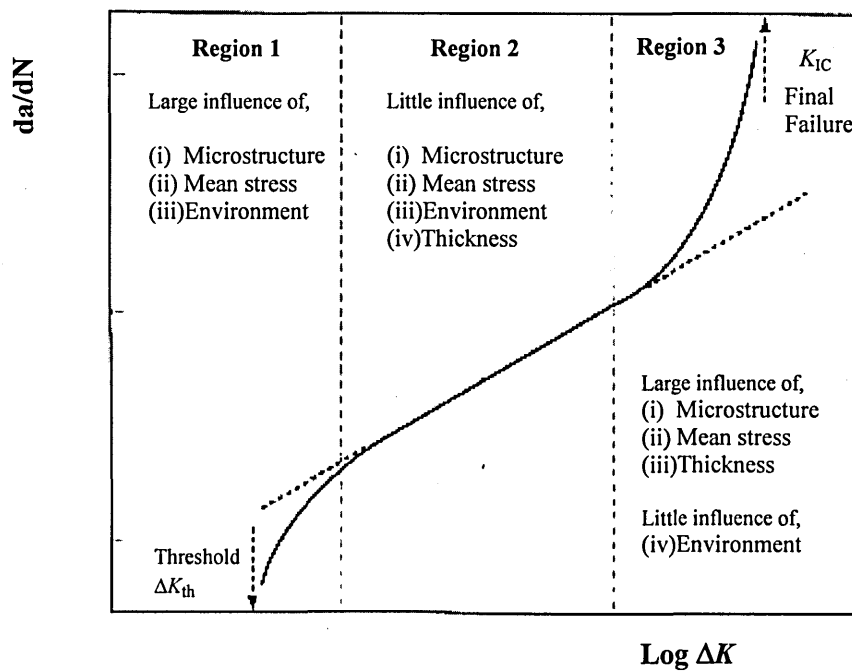
Fig.9: Schematic illustration of fatigue crack growth, da/dN versus ΔK [cited in 39].

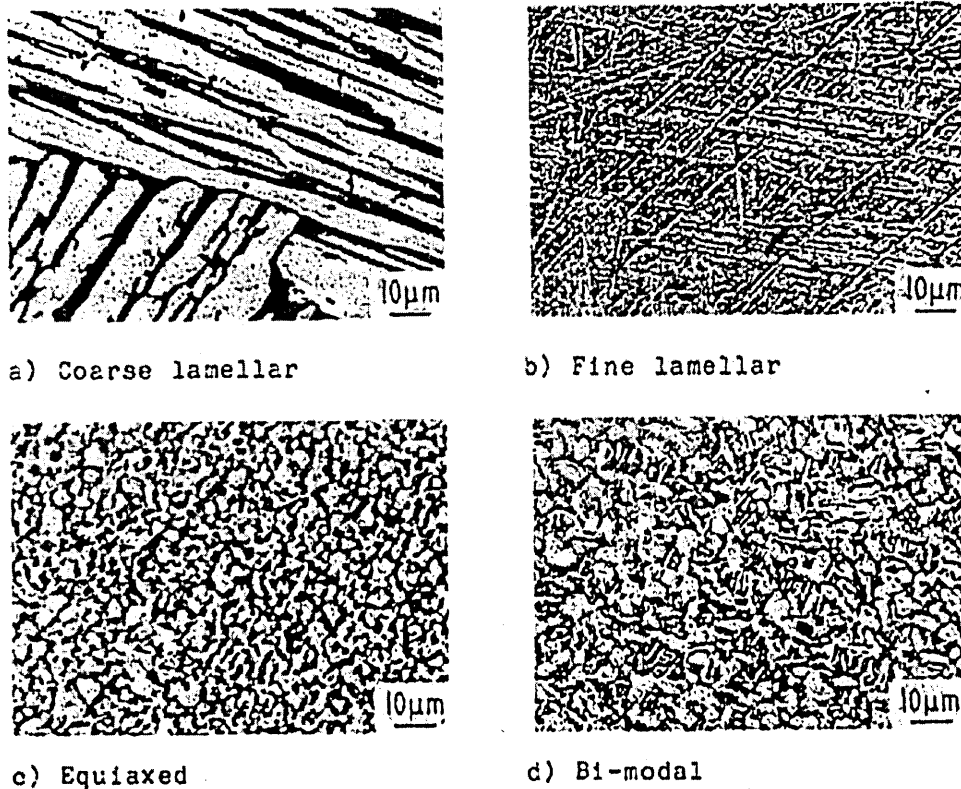
Fig.13: $\alpha + \beta$ structures for Ti-6Al-4V [50].

As explained in chapter 2.5, implant grade Ti-6Al-4V is a $\alpha + \beta$ alloy. The geometrical arrangement of these two phases can be changed to a great extent through different material processing conditions. Fig.13 [50] shows different microstructural morphologies for Ti-6Al-4V. Fig.14 [50] shows the influence of morphology of α and β on the fatigue limit of Ti-6Al-4V.

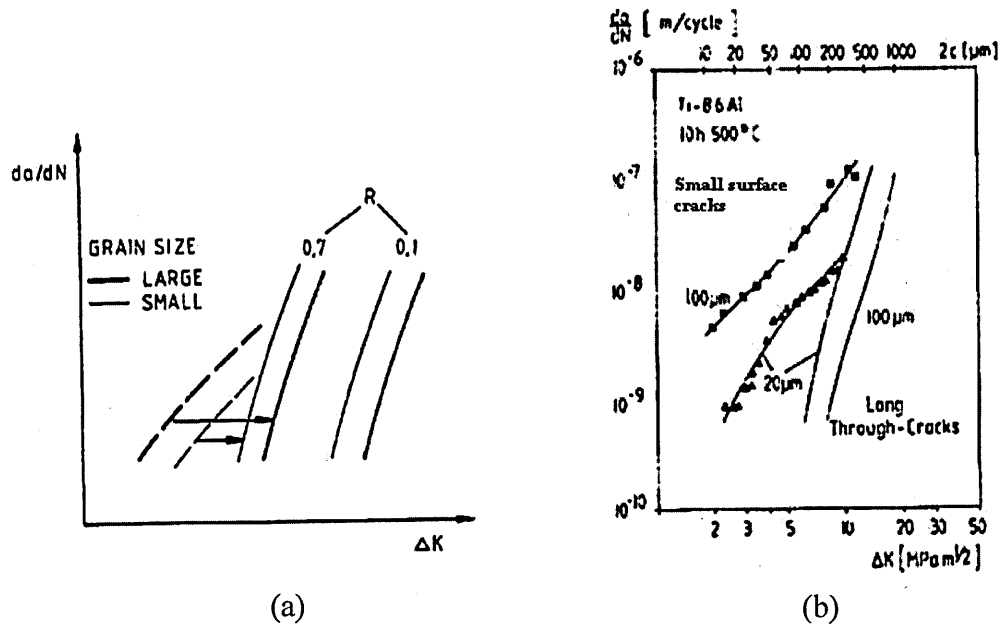
Fig.16: Influence of grain size on da/dN vs. ΔK behaviour for short surface cracks and long cracks , (a) Schématic diagram, (b) For *Ti-8.6Al* (10h, 500°C) [51].

Lutjering *et. al.* [51] also showed, through comparison of average propagation rates of small surface cracks for two grain sizes that small surface cracks propagate at a lower rate in the fine grained material. This is illustrated in Fig.16 [51].

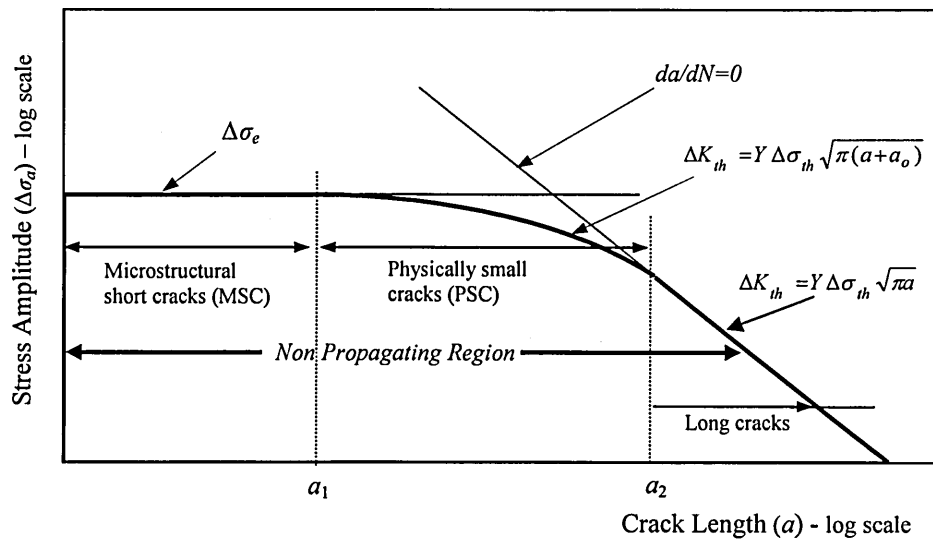
Fig.20: Schematic representation of K-T type diagram [58].

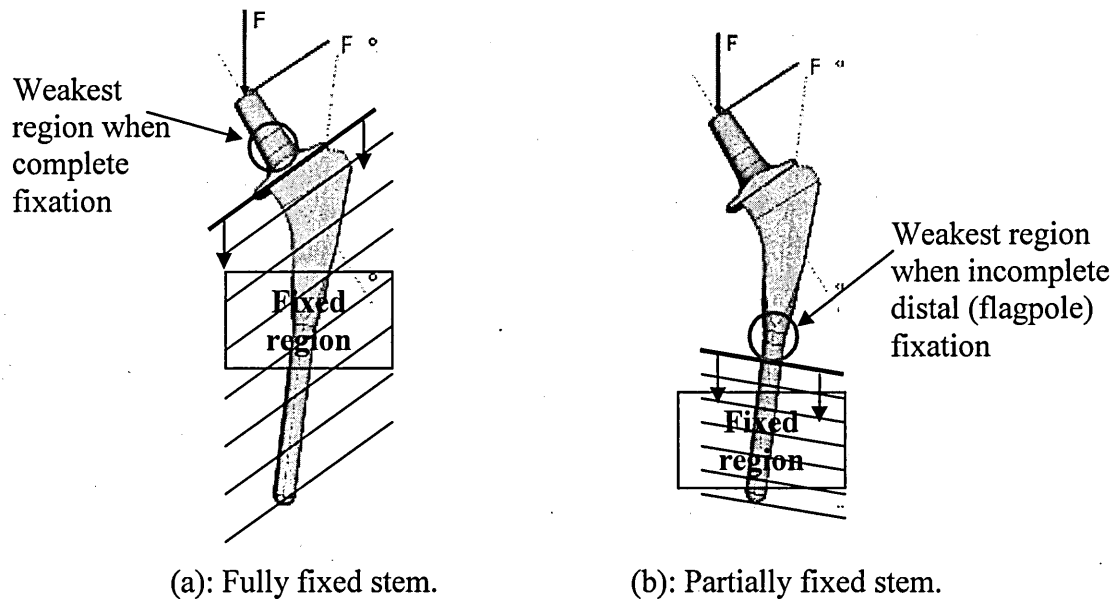
Fig.36: Two different possible fixations of implant with the bone.

The fixation of implant to the bone may not be uniform throughout the H-AC coated stem as expected. The stem could potentially be fixed to number of different depths proximally and distally. Two possibilities of fixation are shown in Fig.36. When an implant is fully fixed to the bone as shown in Fig.36(a), the most susceptible area for failure to occur is the neck region. The failure of a femoral stem at cone region is often associated with osteolysis and loss of proximal fixation as illustrated in Fig.36(b). Partial fixation of the stem with the bone which is known as flagpole fixation, makes the cone region the most critical area to fail [163].

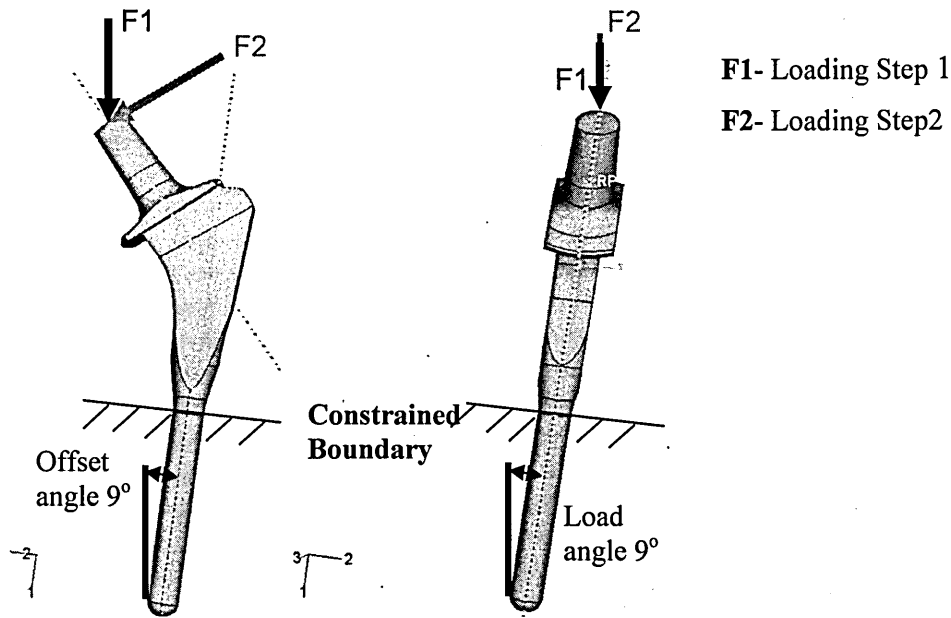
Fig.37: Implant model with constrained and the loading steps [91].

The analysis was performed assuming a partially constrained condition of the femoral stem. The stem was constrained in accordance with BS 7251-Part5 (1990) [92]. In the constrained area all the mesh nodes were constrained in all 6 degrees of freedom. The femoral stem was analysed with two loading conditions, both are point loads, load step 1 and load step 2 as shown in Fig.37 [91]. Step 1 is compressive axial load of $3kN$ applied to the spigot end of the stem and step 2 is a load of $3kN$ applied normal to the axis of the spigot. Loading and load offsets have been conducted in accordance with ISO 7206-4 "Implants for Surgery-Partial and Total Hip Prosthesis - Part 4" [93]. The elastic analysis was performed using ABAQUS™ software. The results (Figs.38 - 40) [91] clearly show the high stress areas of the stem are neck and cone areas. Hence the neck and cone areas are the most susceptible regions to fail under in-vivo loading and fixation conditions. As explained in Chapter 2.7 if the stem is partially fixed the tendency is to fail at the cone area and in fully fixed conditions the most susceptible area to failure is the neck area.

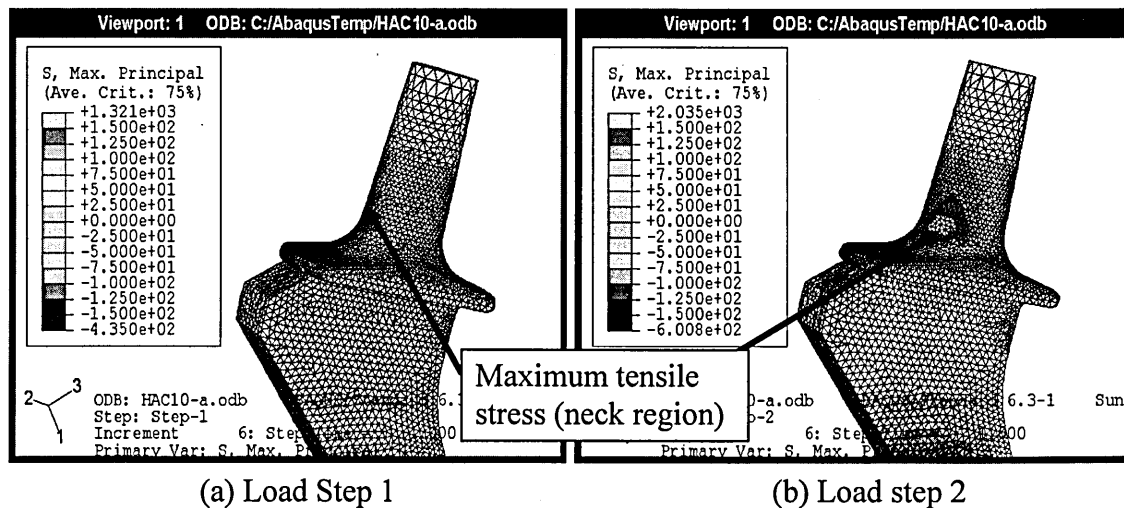
Fig.39: Stress distribution at the neck area under load step 1 and 2 [91].

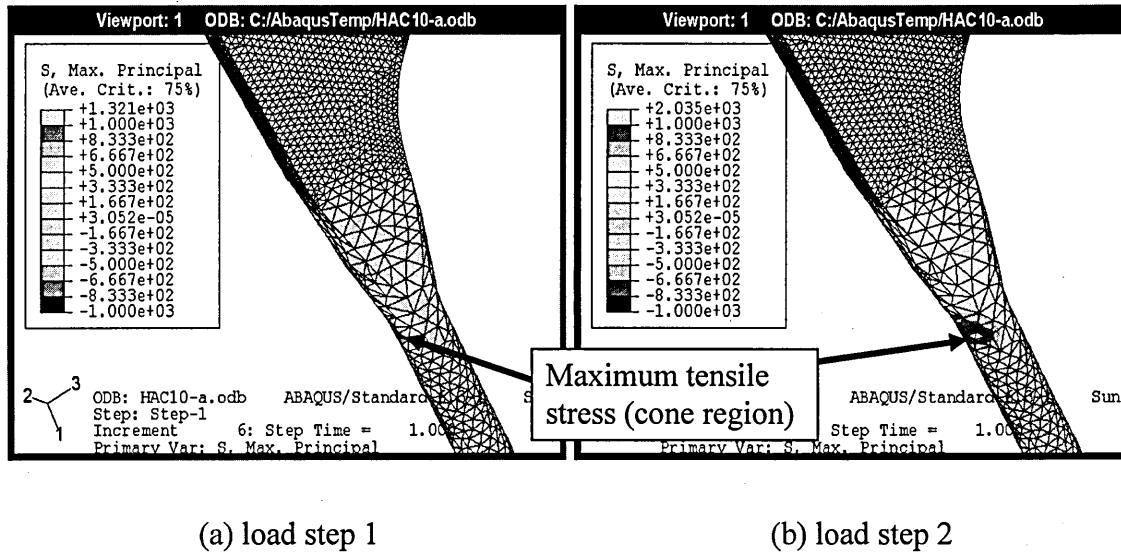
Fig.40: Stress distribution at the cone area under load step 1 and 2 [91].

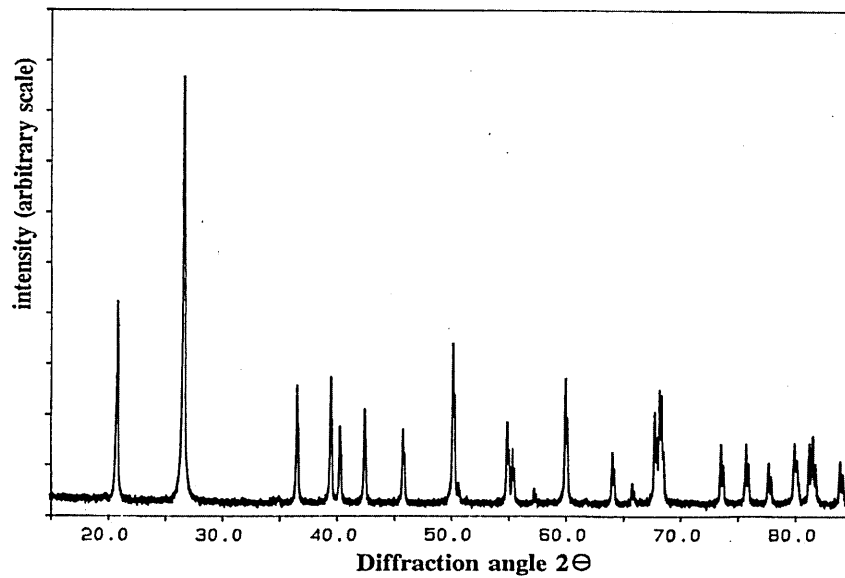
Fig.48: An example of X-ray diffractometer chart of intensity of the reflected beams vs. 2θ angle for quartz SiO_2 specimen [114].

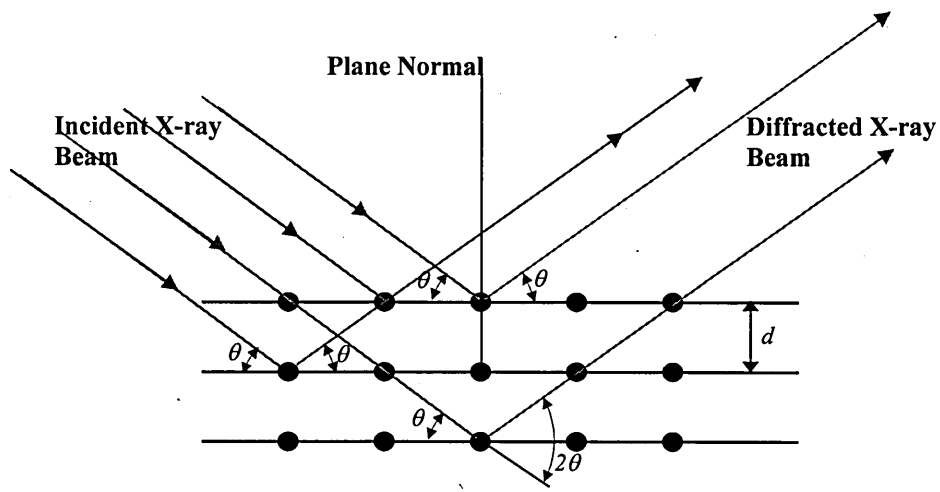
Fig.49: Illustration of X-ray diffraction by a crystal lattice [116].

Fig.49 [116] illustrates the incident and reflected X-ray beam and the notations used. Any change in the lattice spacing, d , results a corresponding shift in the diffraction angle 2θ .

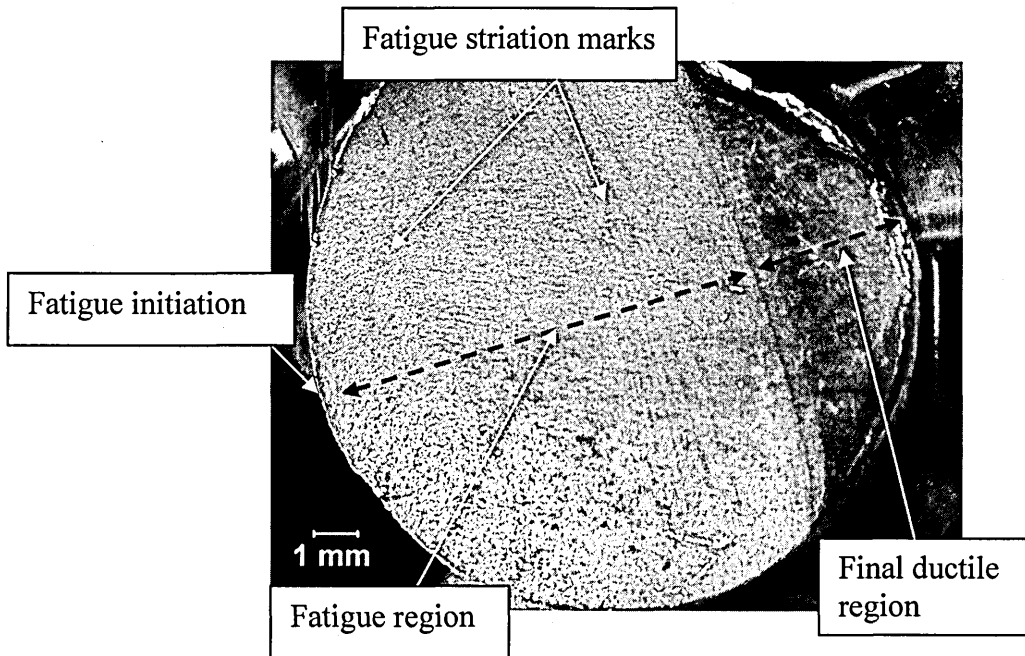
Fig.59: Typical fracture surface of a failed stem [163].

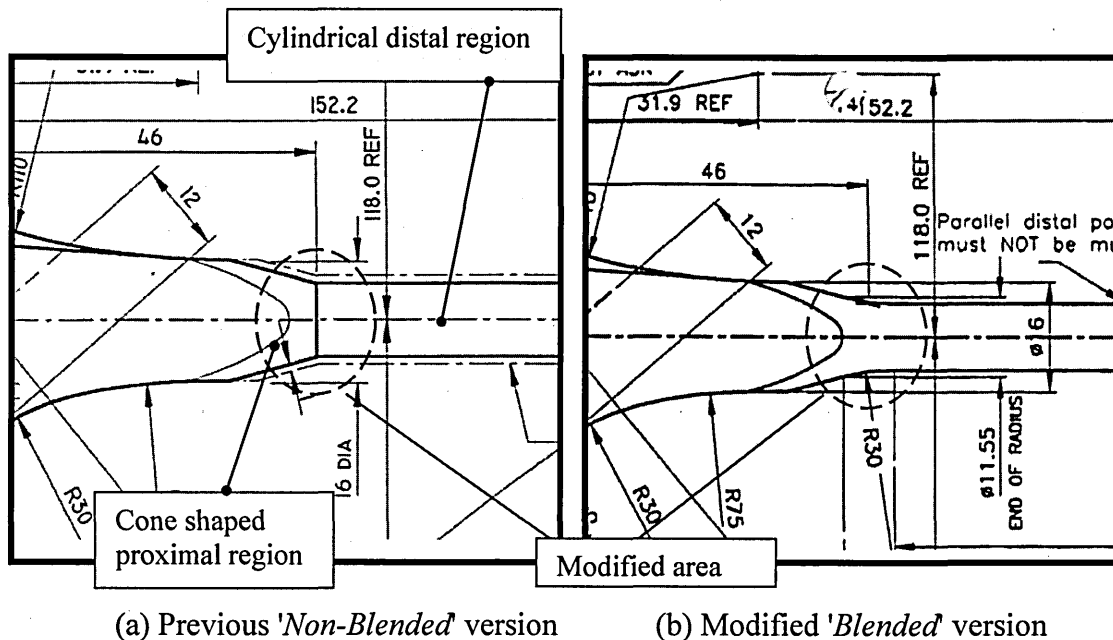
Fig.61: Design modification conducted at the cone region of the hip implants [164].

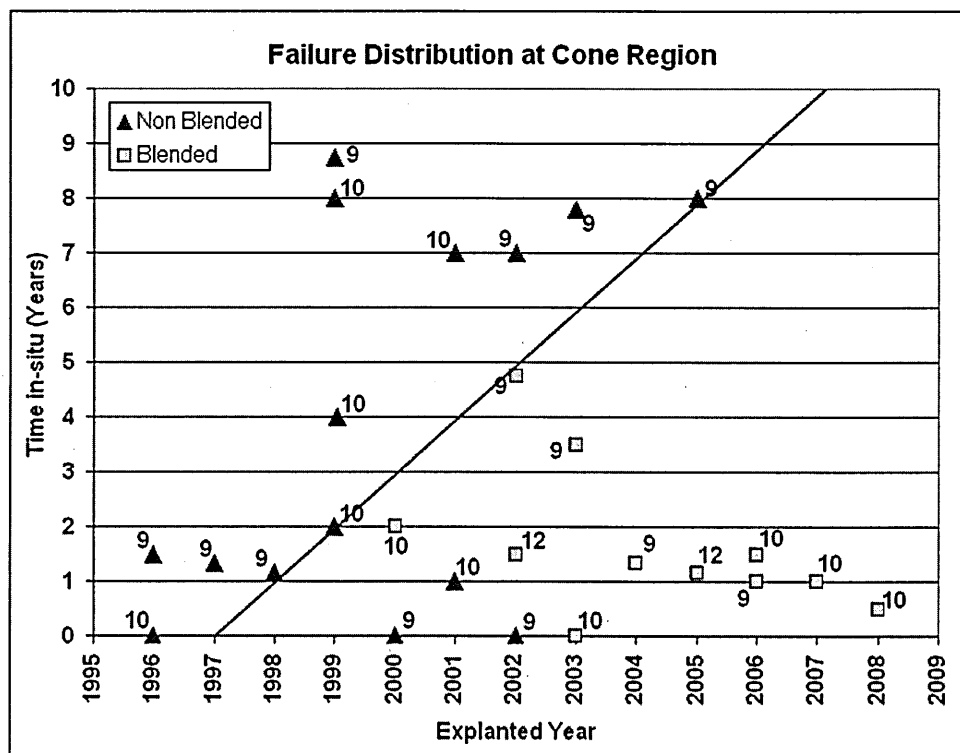
Fig.62: Distribution of failures at cone region

Cone region failure records from 1996 to June 2008 were taken in to account and only the implants that failed in-situ within ten years were considered for this investigation. However these implants are intended to be in-service throughout the life time of the patient. During this period 26 cone failures were recorded. The JRI quality complaints records relating to these failures were investigated. Appendix.1 shows important information such as service time, defects at initiation, possible causes and related remarks, of several selected cone failures. The distribution of the service life of failed implants against the implanted year is shown in the Fig.62.

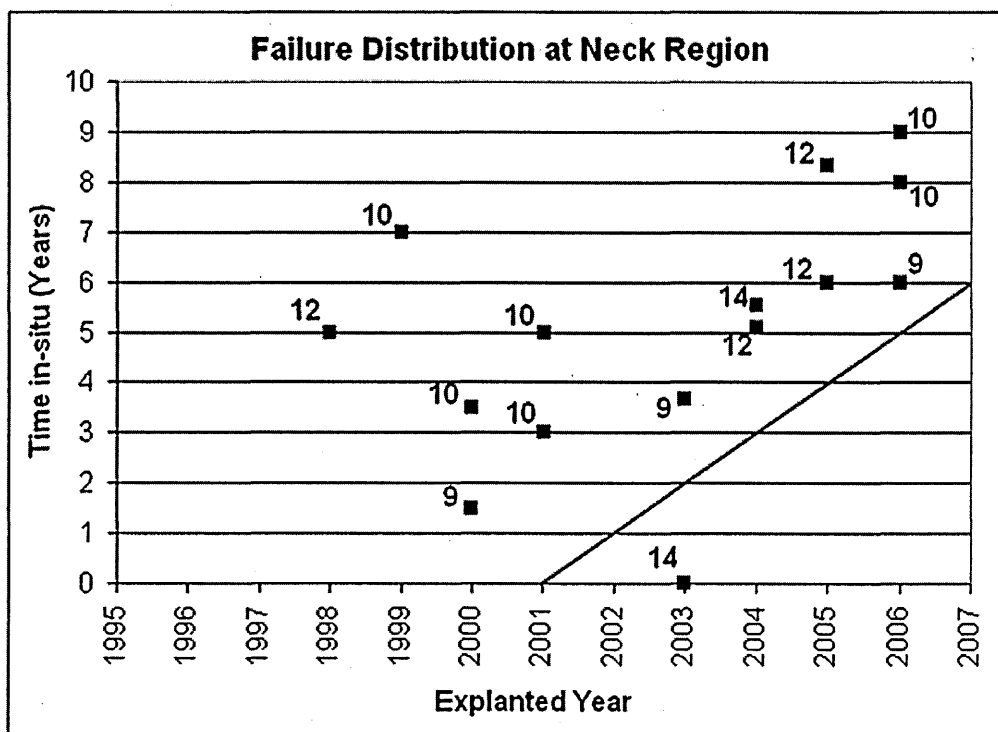
Fig.66: Distribution of failures at neck region.

Failure records from 1998 to June 2008 were taken in to account. As in the case of cone failures only the in-situ failed implants within ten years were considered for this investigation. During this period 15 neck failures were recorded. The JRI quality complaints reports under these failures were investigated. The Appendix.2 shows important information such as service time, defects at initiation, possible causes and related remarks, of several selected neck failures. The distribution of the service life of failed implants against the implanted year is shown in Fig.66.

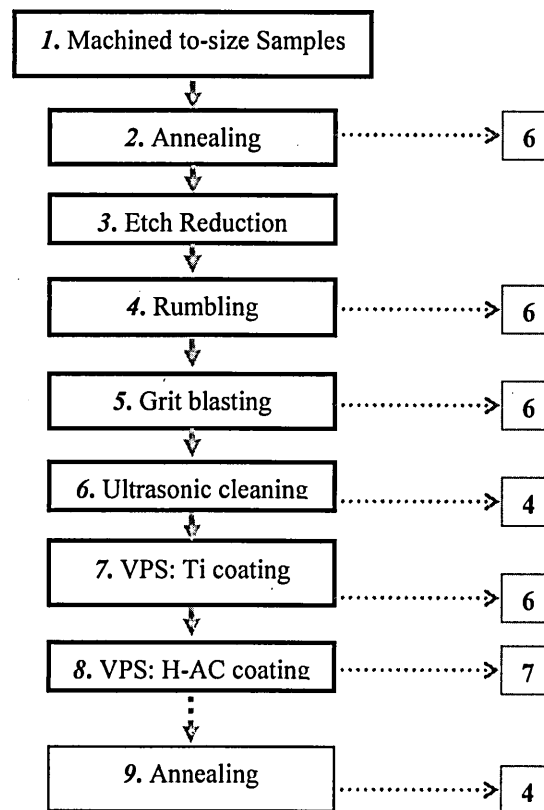
Fig.68: Manufacturing processes investigated under Route.1. Small boxes indicate the number of samples tested at each stage.

The flow chart in Fig.68 illustrates the manufacturing sequence of Route.1 and the number of samples tested under each stage. These samples were used to obtain the surface roughness/defect size, residual stress and fatigue performance data at each stage.

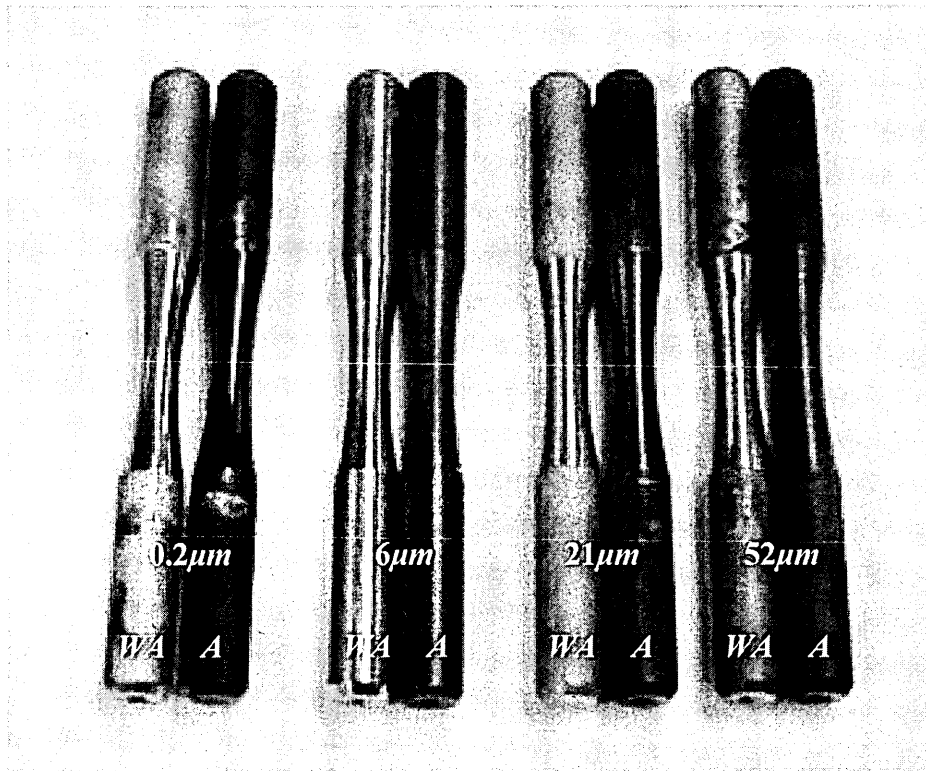
Fig.87: Four samples types prepared for Phase.1 fatigue tests.

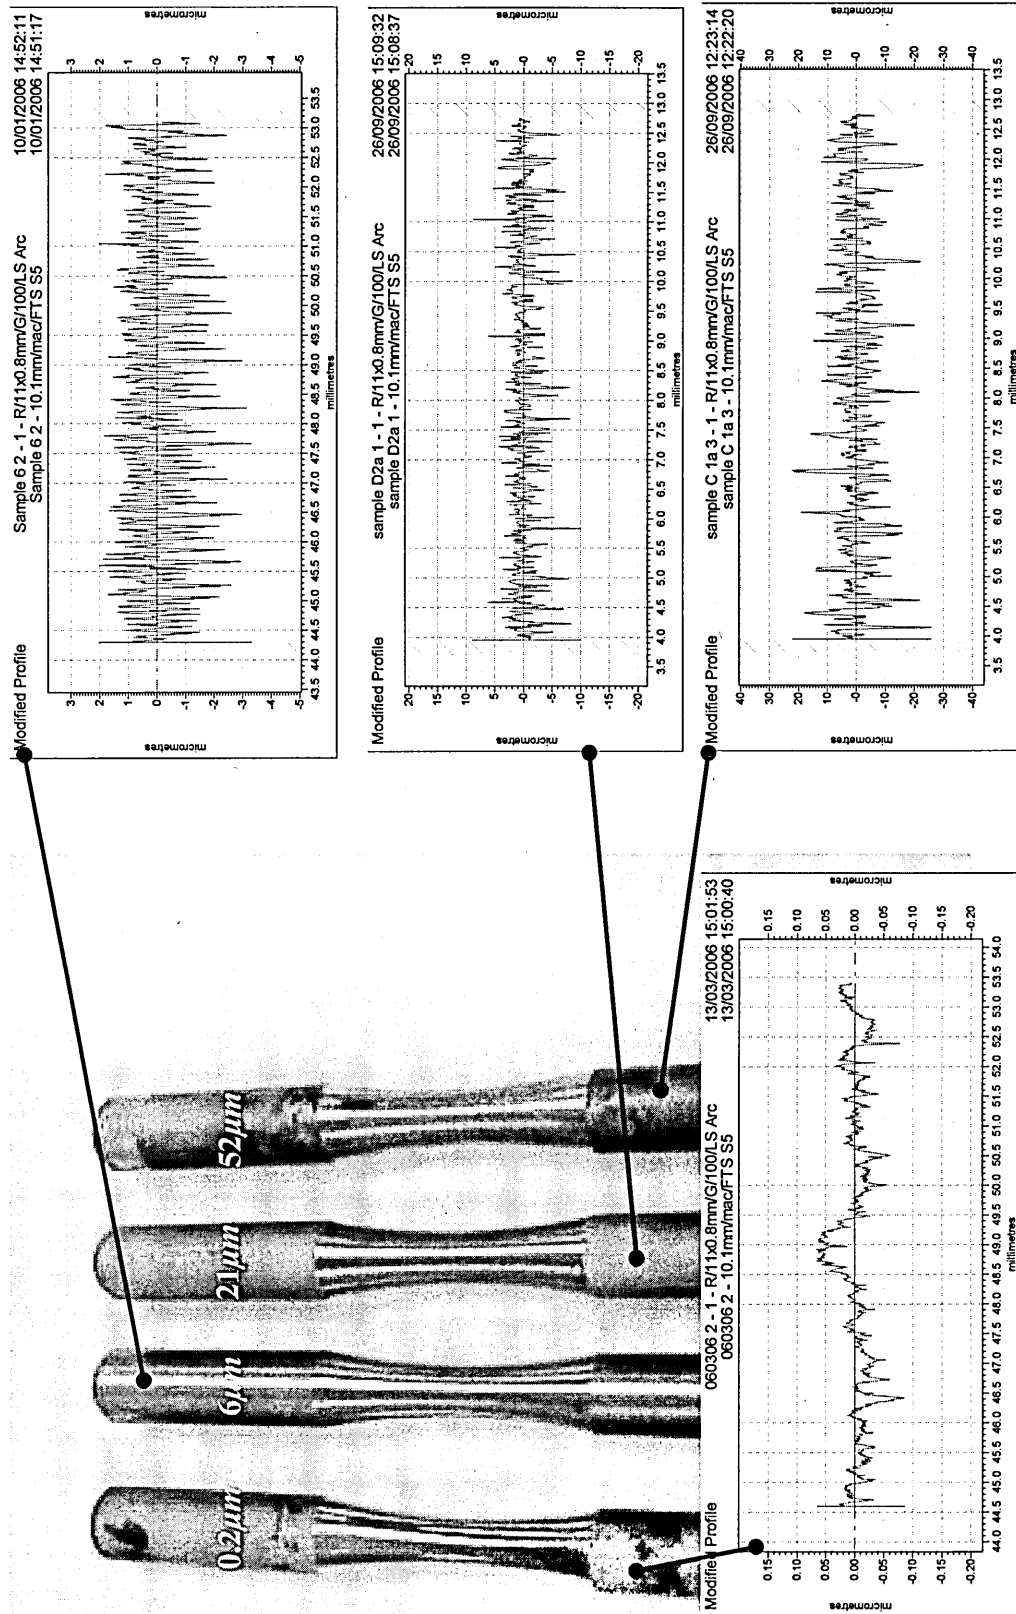
Fig.88: Surface profiles of four different surface conditions (Phase.1 fatigue tests).

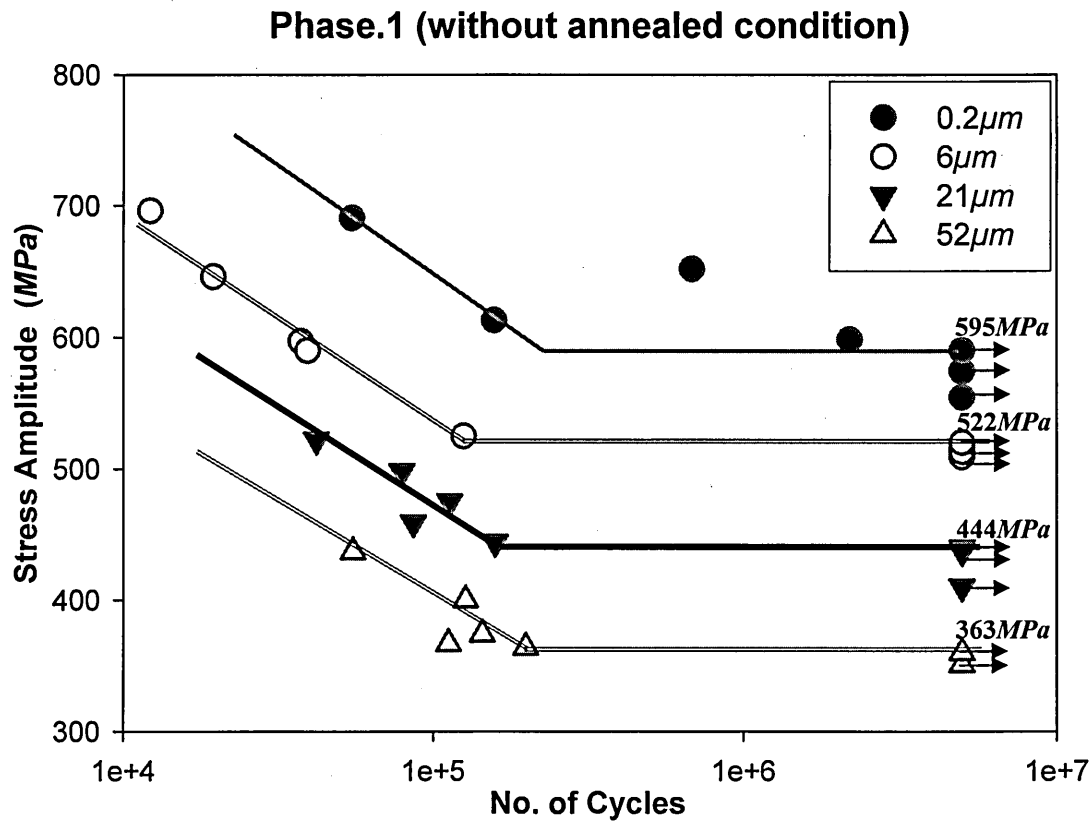
Fig.90: Variation of fatigue endurance limits of samples WA condition. Respective fatigue limits are noted.

Fatigue tests were conducted and $S-N$ diagrams obtained at each stage. Fig.90 shows the variation of fatigue endurance limit of non-annealed (WA) samples.

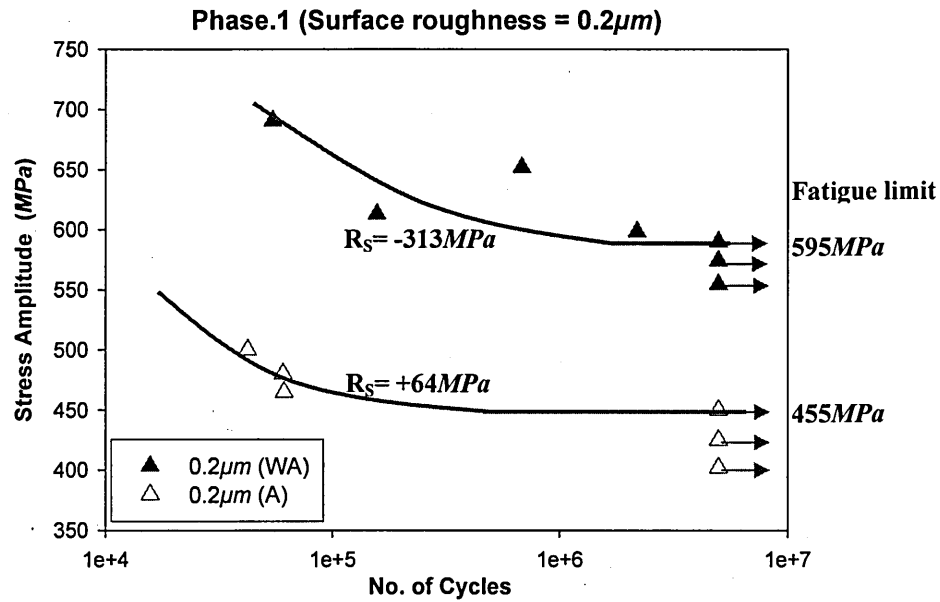
Fig.91: Fatigue curves of samples finished to a surface roughness of $0.2\mu m$; *A* and *WA* conditions. Respective values of residual stress and fatigue limit are noted.

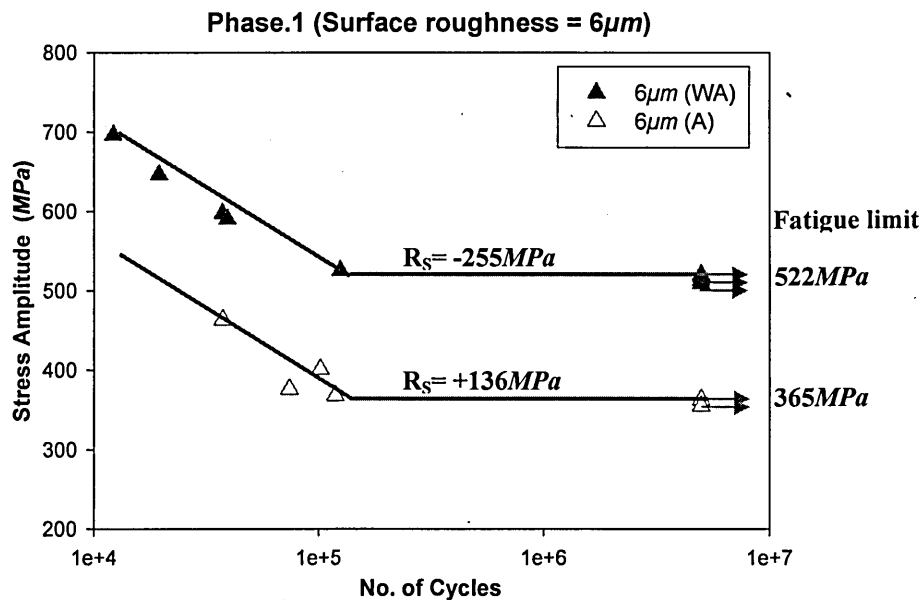
Fig.92: Fatigue curves of samples finished to a surface roughness of $6\mu m$; *A* and *WA* conditions. Respective values of residual stress and fatigue limit are noted.

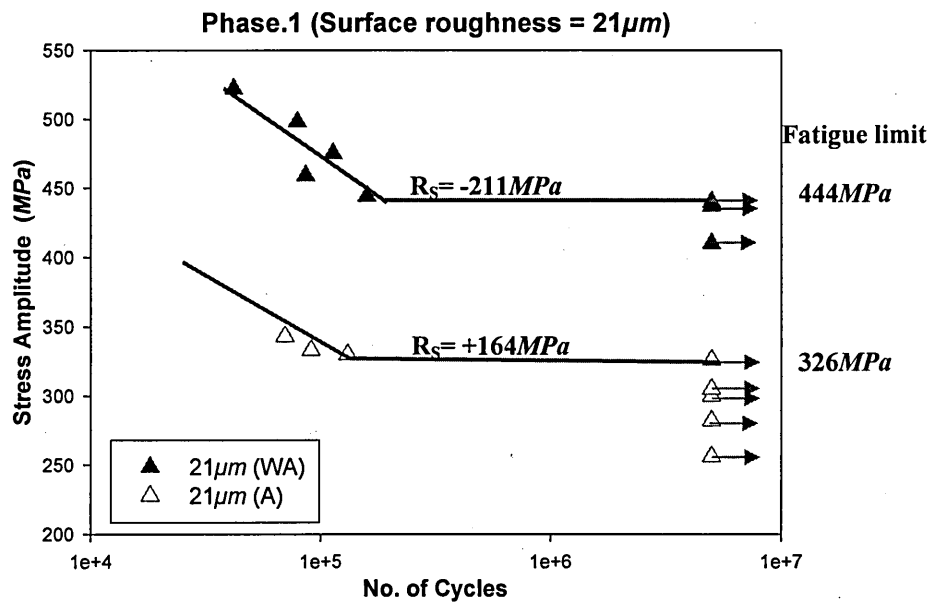
Fig.93: Fatigue curves of samples finished to a surface roughness of $21\mu\text{m}$; *A* and *WA* conditions. Respective values of residual stress and fatigue limit are noted.

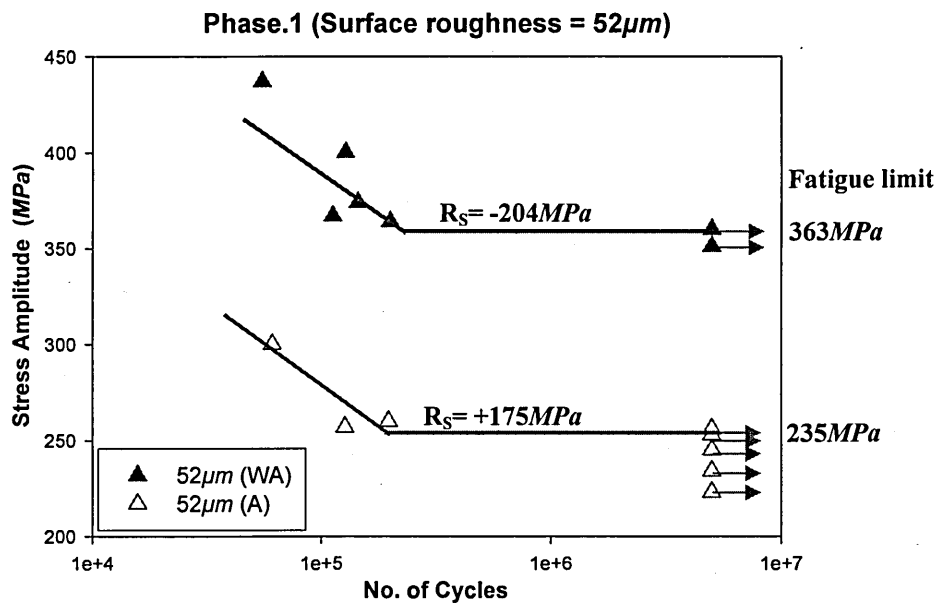
Fig.94: Fatigue curves of samples finished to a surface roughness of $52\mu\text{m}$; *A* and *WA* conditions. Respective values of residual stress and fatigue limit are noted.

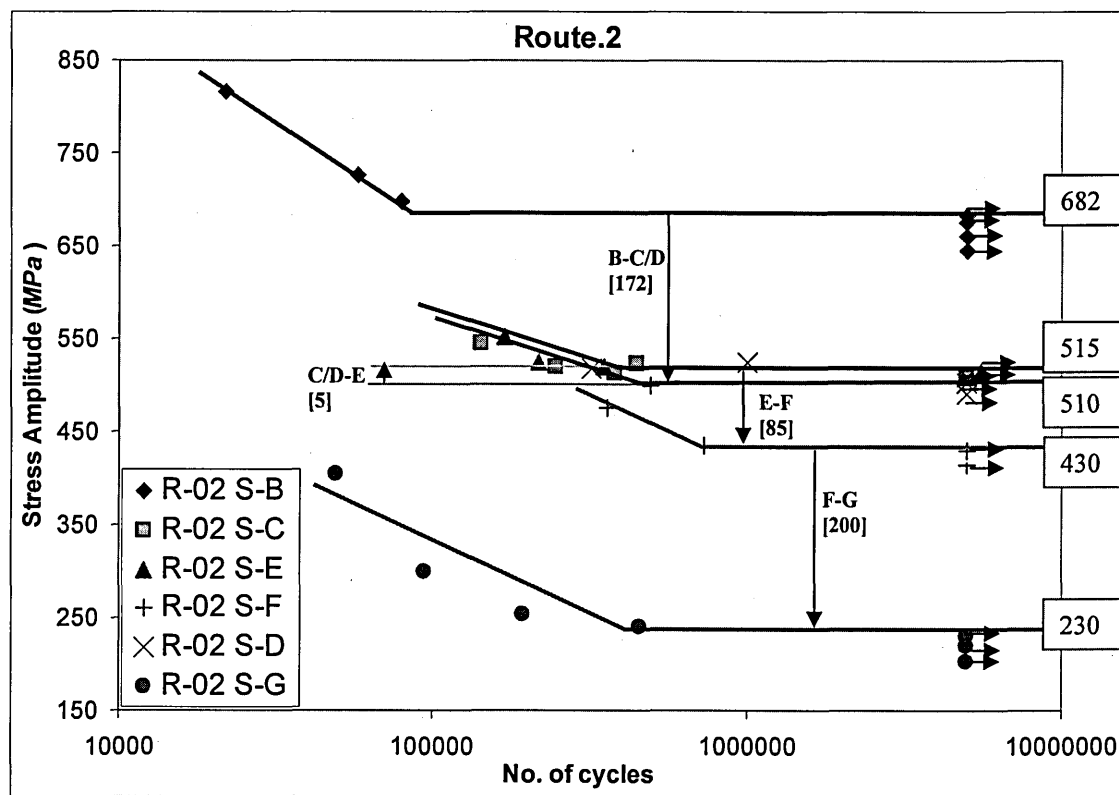
Fig.98: Fatigue endurance limit at each stage for Route.2.

The variation of fatigue limit at each manufacturing stage for Route.2 is shown in Fig.98.

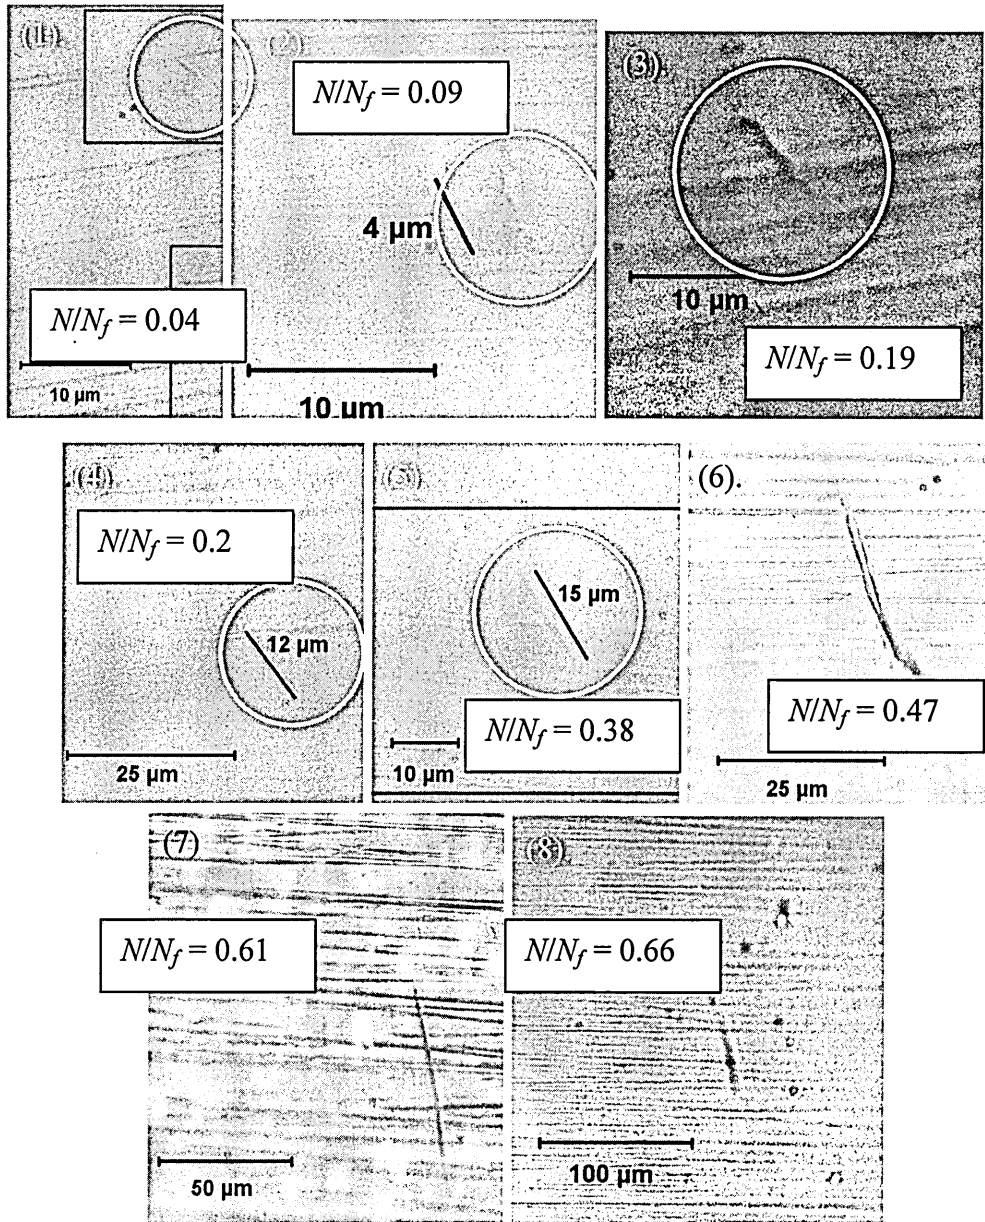
Fig.101: Pictures of fatigue cracks obtained by surface replication. (Note: figures 1-9 are investigated by optical microscope, figures 10-12 are investigated by IFM)

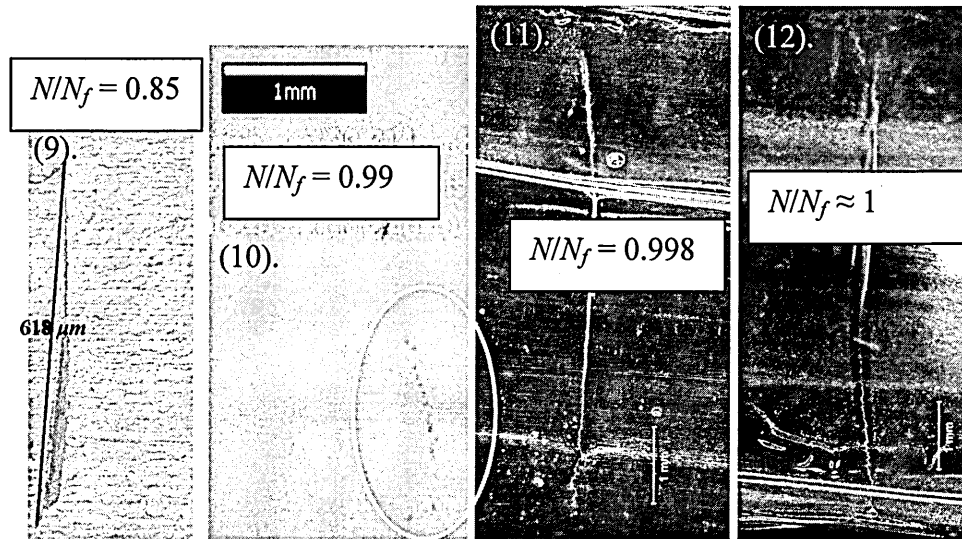
The variation of crack length with the number of cycles is illustrated in Table.14 and Fig.102.

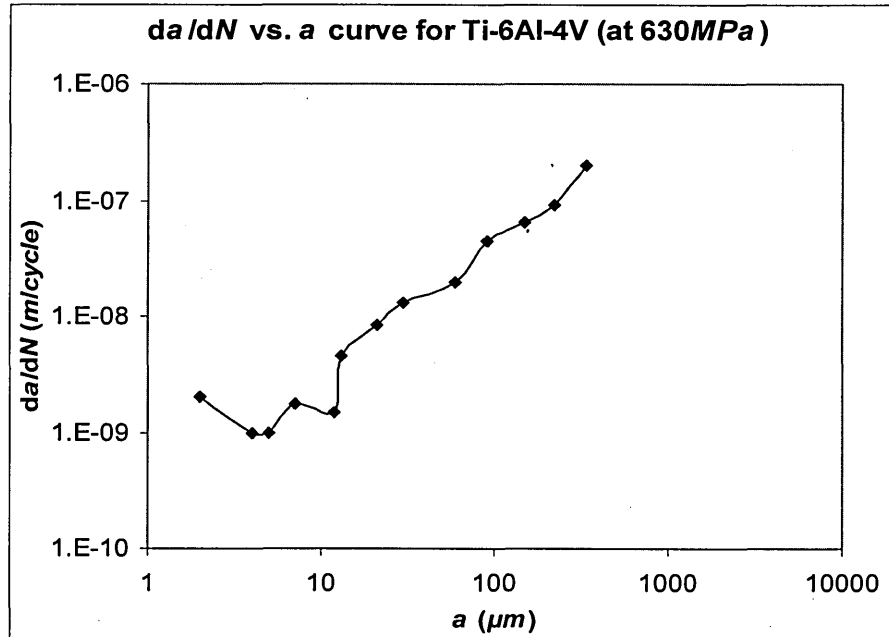
Fig.103: Variation of fatigue crack growth rate (da/dN) against the crack length (a)

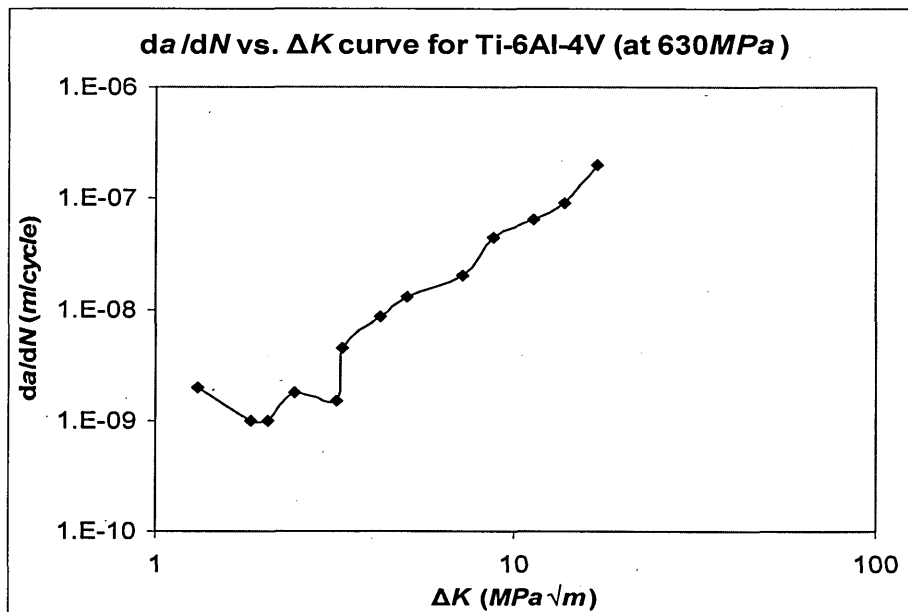
Fig.104: Variation of da/dN against stress intensity factor (ΔK).
